Accident Info-Gram
APRIL 2002

Fuel Truck Fire

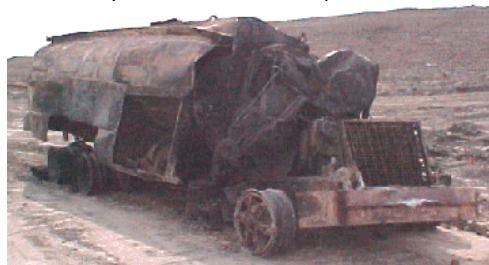
A fuel truck recently caught fire at a District 8 surface mine. While fueling a DML 60 Ingersoll-Rand overburden drill, the drill operator observed flames coming from the rear of the fuel truck. Due to the flames, the operator was unable to reach the fire extinguisher mounted on the rear of the fuel truck. He then retrieved a fire extinguisher from the drill, but he was unable to extinguish the fire. After notifying the pit foreman of the fire, the drill operator moved the drill to a safe location. The foreman summoned two local fire departments. Then he and other miners tried to extinguish the fire with portable dry-chemical fire extinguishers, but they were unable to bring the fire under control. After approximately twenty minutes from the discovery of the fire, the fire companies arrived and applied water and foam. This was not effective in controlling the fire. The pit foreman evacuated the area and the fire was allowed to self-extinguish. After approximately fifty minutes from its initial discovery, the fire ceased to burn. No injuries were sustained in the incident, but the fuel truck suffered extensive damage. Examination of the fuel truck revealed the tank had ruptured at a seam at the front of the tank. The high pressure built up during the fire may have caused this rupture.

- Fuel trucks should be provided with at least two readily accessible large fire extinguishers mounted on opposite ends.
- Extensive fire fighting efforts should not be continued when the fire area includes a fuel tank. An explosion may occur due to expansive vapors in the tank. The area should be vacated and the fire allowed to self-extinguish.
- Fuel trucks should be equipped with automatic fire

suppression system.
